Report on Architectural Recording and Archaeological Survey Undertaken at Nu'aija, Doha

May 2015

Daniel Eddisford and Robert Carter

Origins of Doha Project

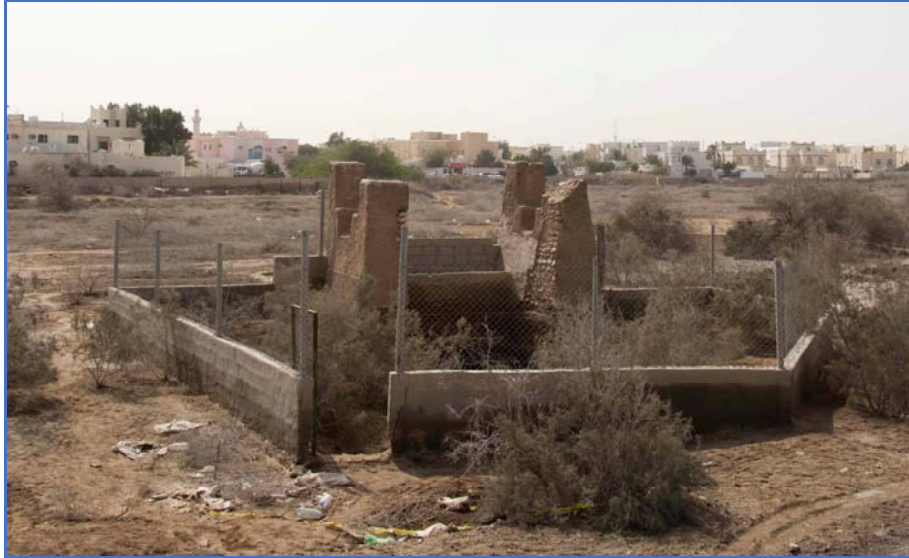
Figure 8: The *Zajara* well, Structure 1, looking south.

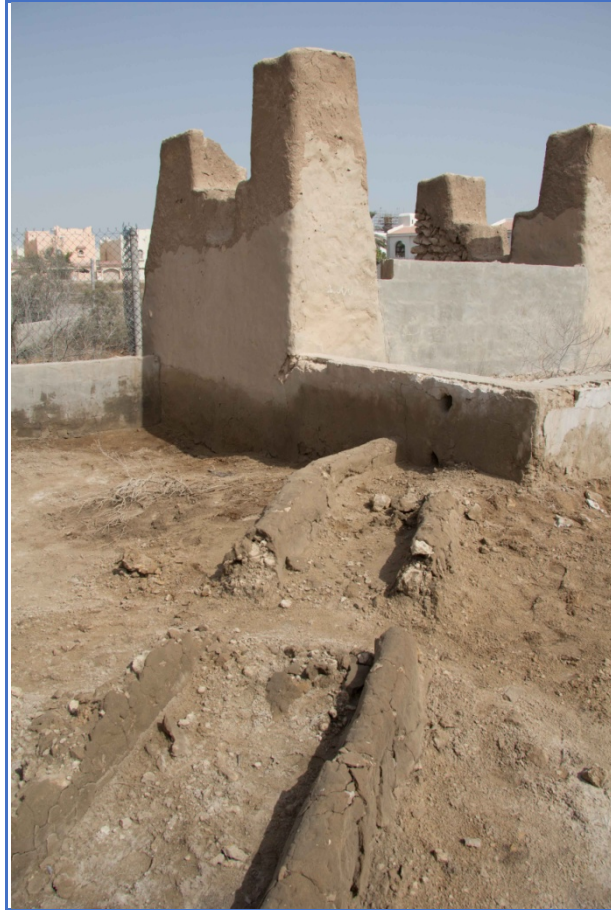
Drainage holes in the eastern and western side of the tank fed into channels, built of limestone and a hard brown render (Figure 17). This constructing is similar in appearance to the earlier phase of the tank itself. These channels would have fed the water into a series of small canals, allowing the water to be diverted into the required area of the site to irrigate the crops.

Figure 17: Channel leading from the water trough into the fields.

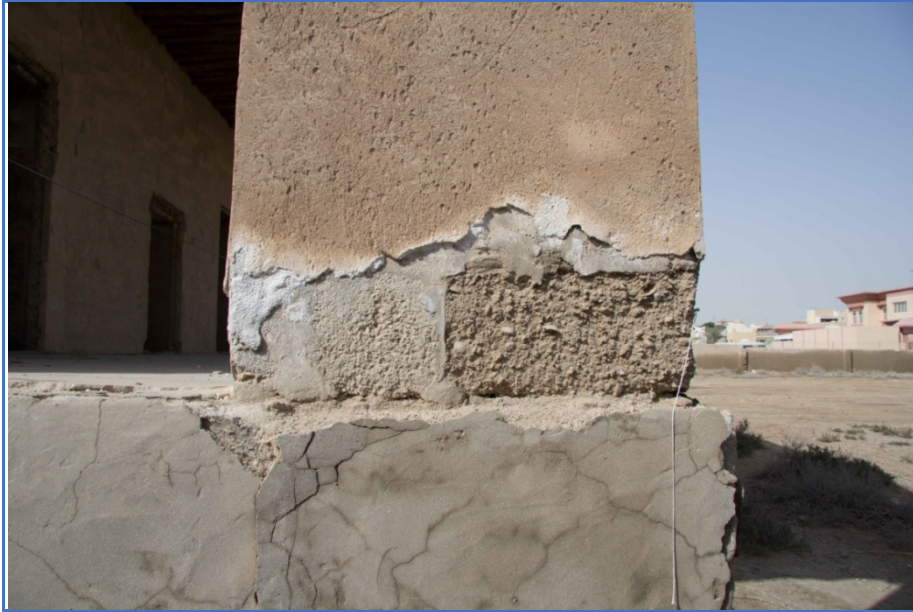
The *majlis* is built of concrete blocks, which contain a large amount of shell temper (Figure 22). These are identical in appearance to the shell tempered concrete blocks used to construct the boundary wall (Structure 15), stables (Structures 3 and 4) and the large water tanks on the site (Structures 6, 8, 9, 10, 11 and 12). The building is covered in a hard brown render, and where this is missing the exposed concrete blocks are rapidly disintegrating. Two sets of stairs give access to the *liwan* from the southern and western side (Figure 23).

Figure 22: Shelly concrete block construction and external render

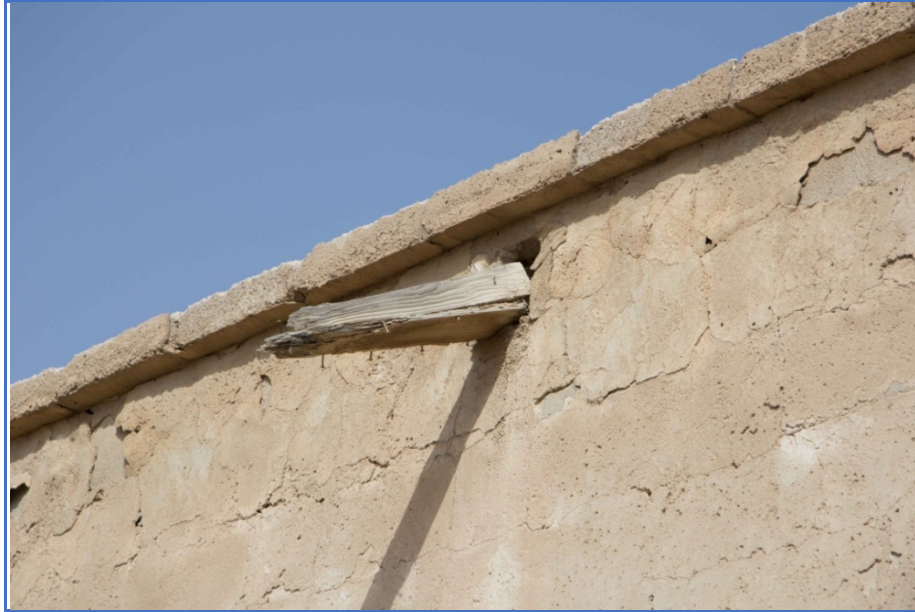
Figure 28: Water spout on the roof of the majlis.

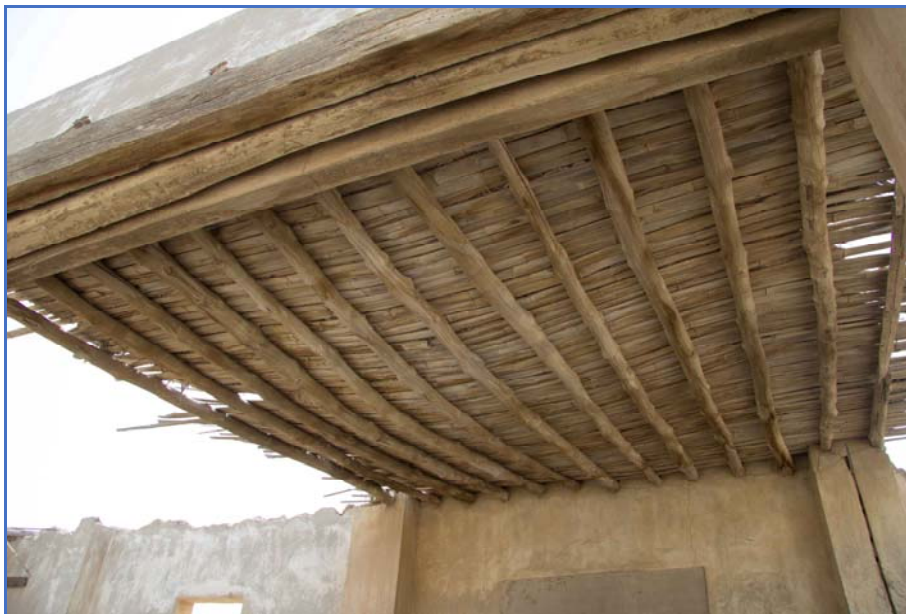
The stable block was covered with a traditional style roof, consisting of round *danshal* beams laid directly on top of the walls and covered with a layer of split bamboo, and woven reeds or palm fronds. The roof was made watertight with the addition of a 0.10m thick layer of mud (Figure 50). Although similar in appearance to the ceiling in the *majlis* building, Structure 1, the roofing style is not as elaborate as was often used in higher status buildings.

Figure 50: Traditional roofing in Structure 3.

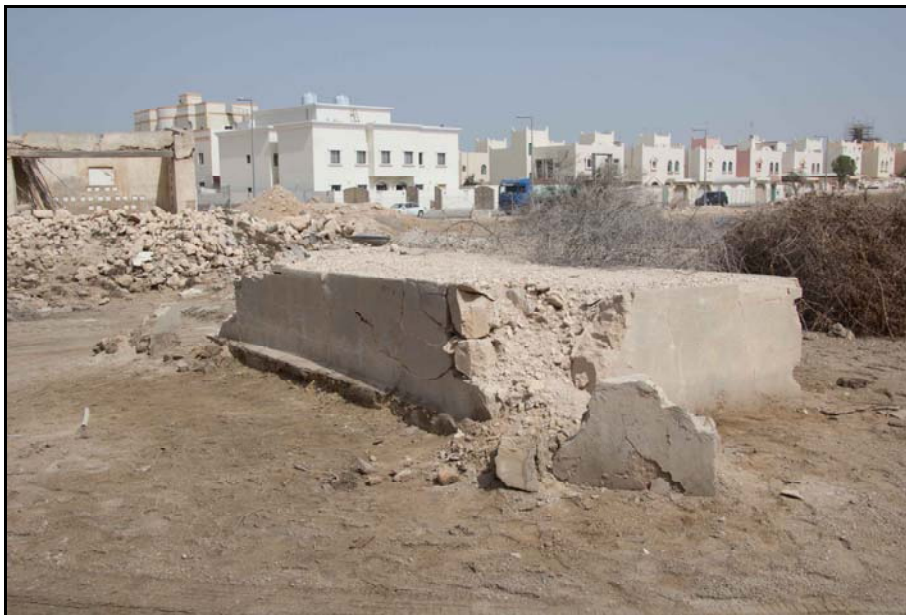
Located in-between stable buildings Structure 3 and Structure 4 was a rectangular in-filled water trough or tank measuring 5.10m x 2.00m and standing 0.85m high (Figure 58). This trough, Structure 5, was built of hollow concrete blocks, tempered with shells and gravel. The trough is covered with a hard grey render. The lowest course of concrete blocks form a slightly wider foundation. Overall the construction of this feature is very similar to the tanks associated with wells Structures 8 - 12, and is likely to have been constructed at a similar point in time. However the elongated shape of this feature, and the fact it is located to a stable block as opposed to a well, suggest it was used to hold water for horses as opposed to being used as part of the irrigation of the agricultural element of the site.

Figure 58: In-filled water trough, Structure 5, looking northeast.

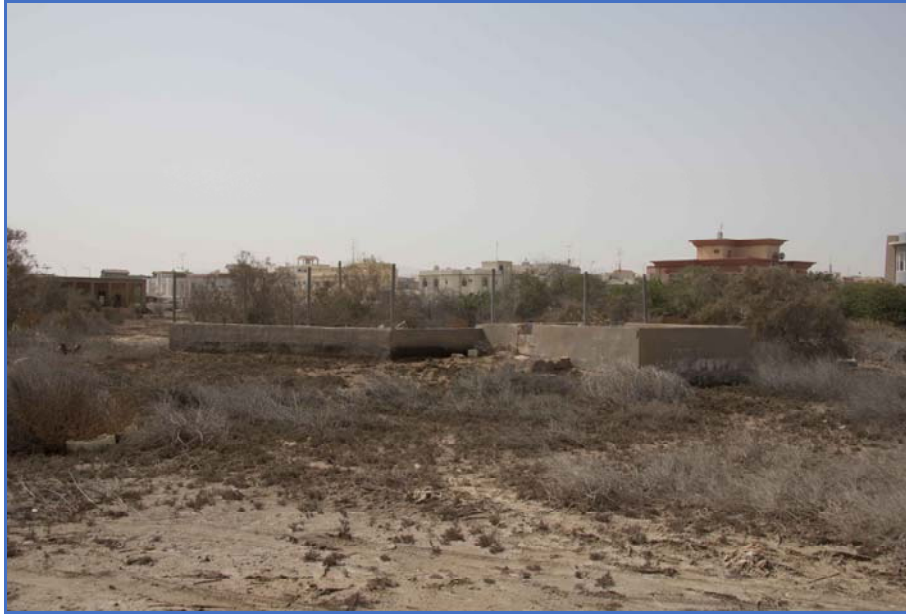
Structure 8 consists of a partially infilled well with a raised water tank located on its northern side. The well is enclosed by a later modern concrete enclosure and chain-link fence, with an entrance in the southwest corner; this wall is partially collapsed in places (Figure 70). This feature is very similar in appearance, use, and life history to Structures 9, 10 and 12.

Figure 70: Well, enclosed by modern wall, and raised tank to the right (Structure 8).

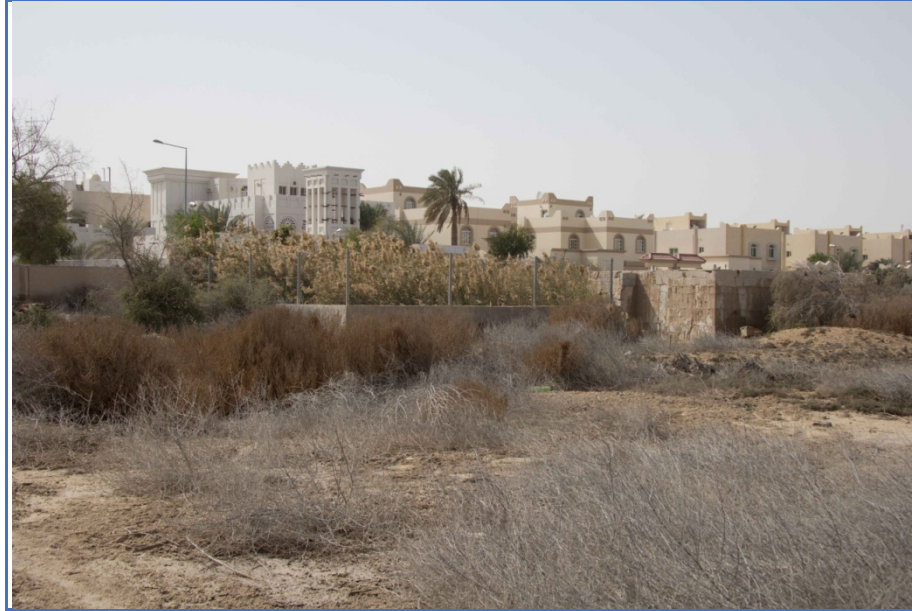
Structure 10 also consists of an overgrown well with a raised water tank, accessed by steps, on its eastern side. Three concrete bases, located directly to the east of Structure 10 supported pumping equipment, with one pump still in-situ. The well is again enclosed by a later wall and chain-link fence.

Figure 77: Overgrown well with raised tank to the right, Structure 10 looking southwest.

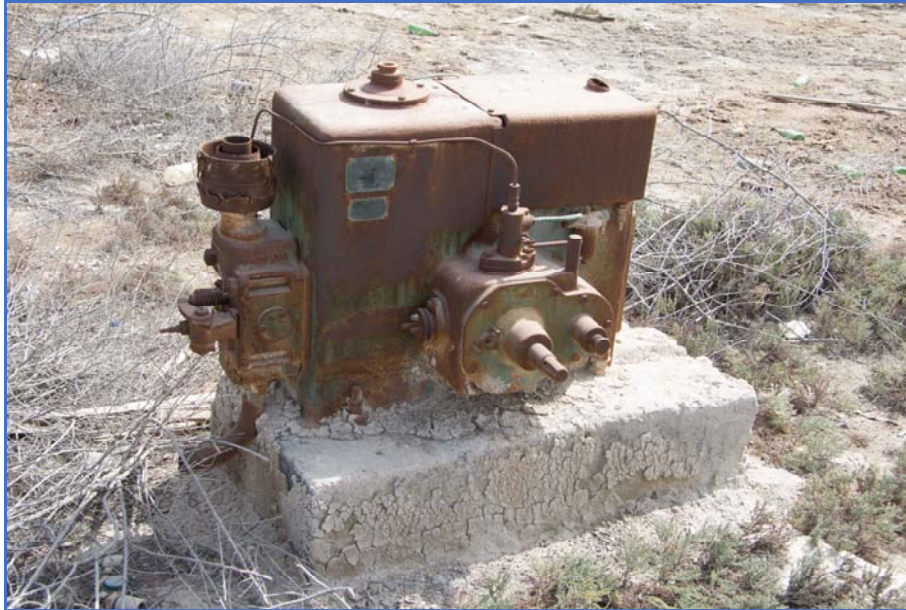
Figure 80: In-situ pump associated with Structure 10.

The pump still retains its makers plaque, it is partially corroded and hard to make out, but appears to read:

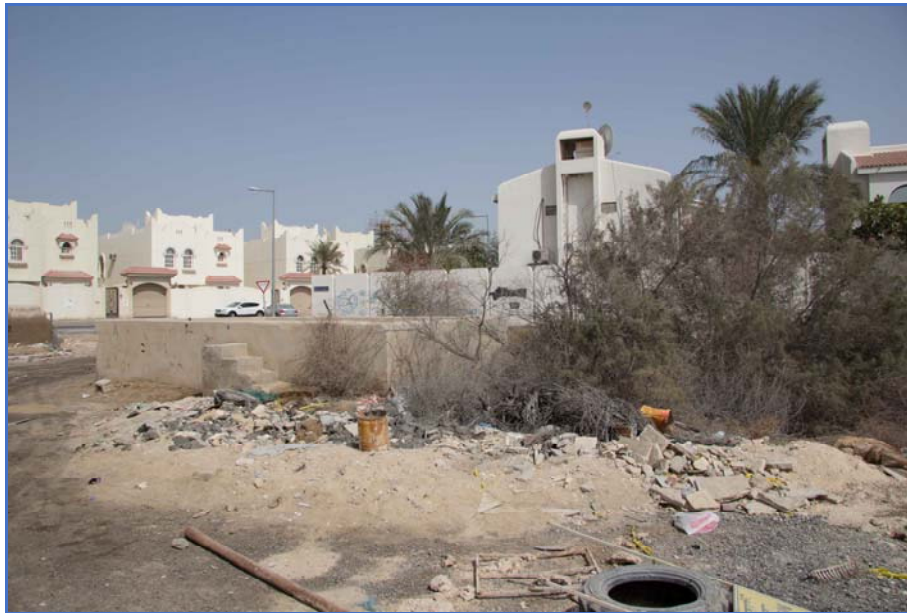
Figure 81: Overview of tank Structure 11, looking northeast. Shrubs on the right are growing in the partially infilled well

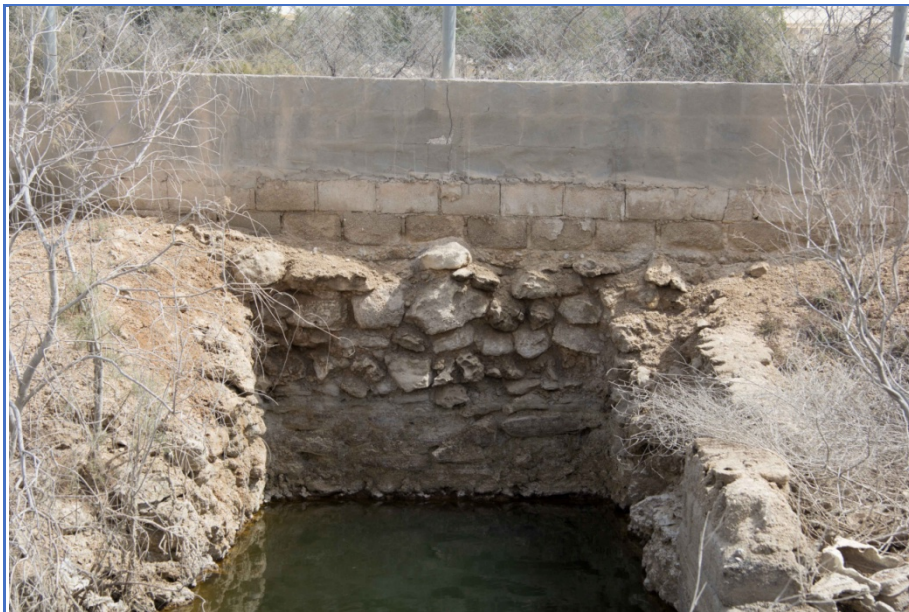
Figure 83: Earlier stone well lining, below later concrete additions associated with Structure 12, looking east.
