Report on Architectural Recording and Archaeological Survey Undertaken at Nu'aija, Doha

May 2015

Daniel Eddisford and Robert Carter

Origins of Doha Project

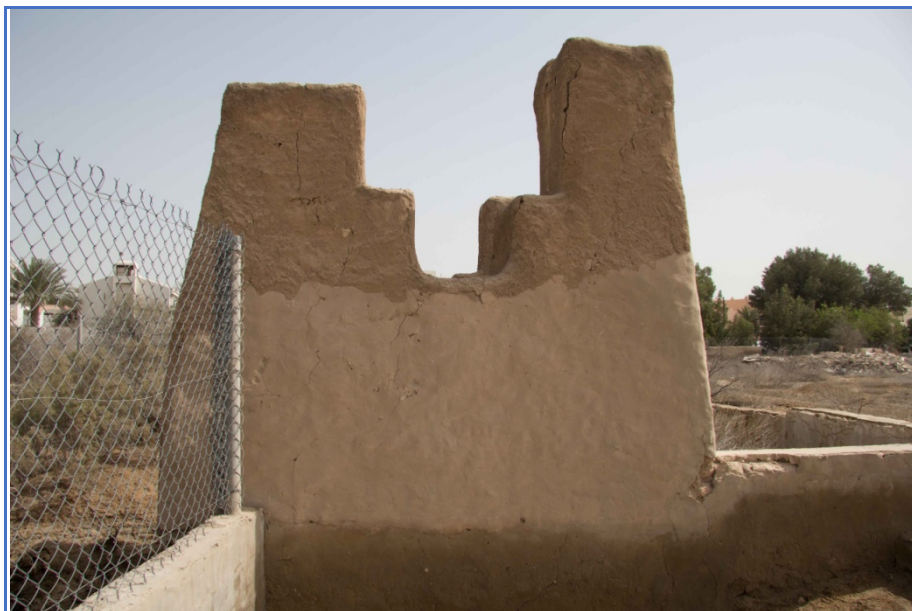
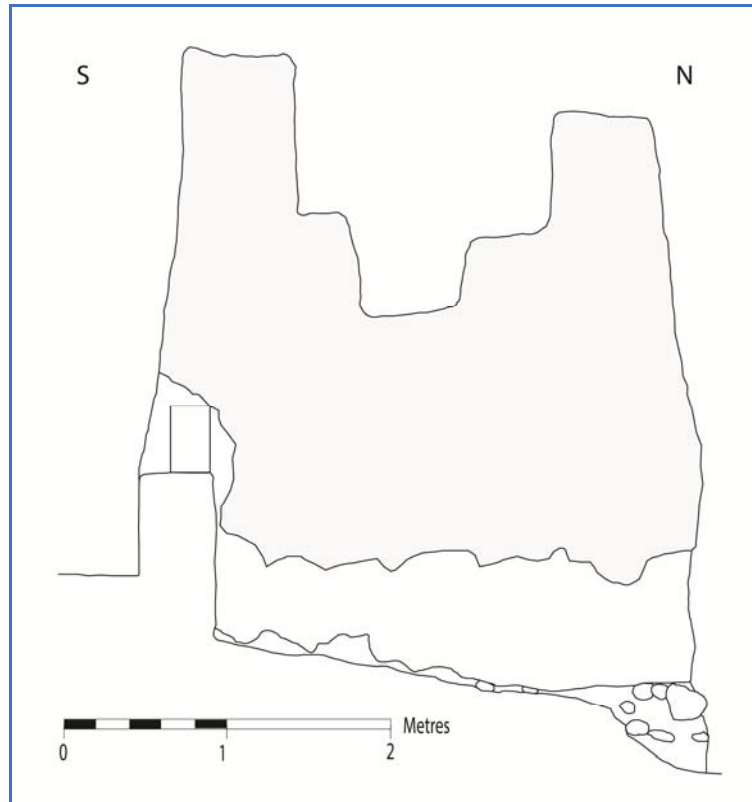
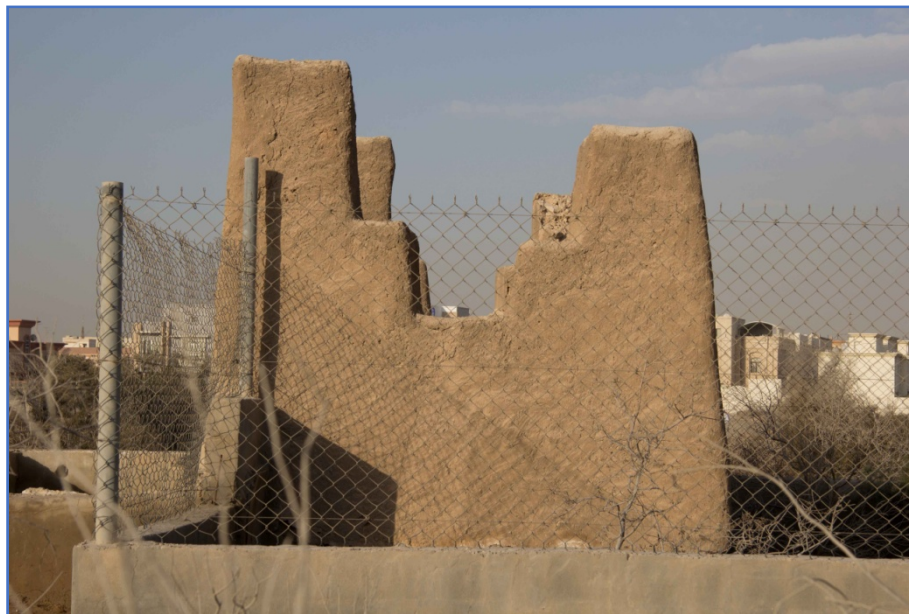
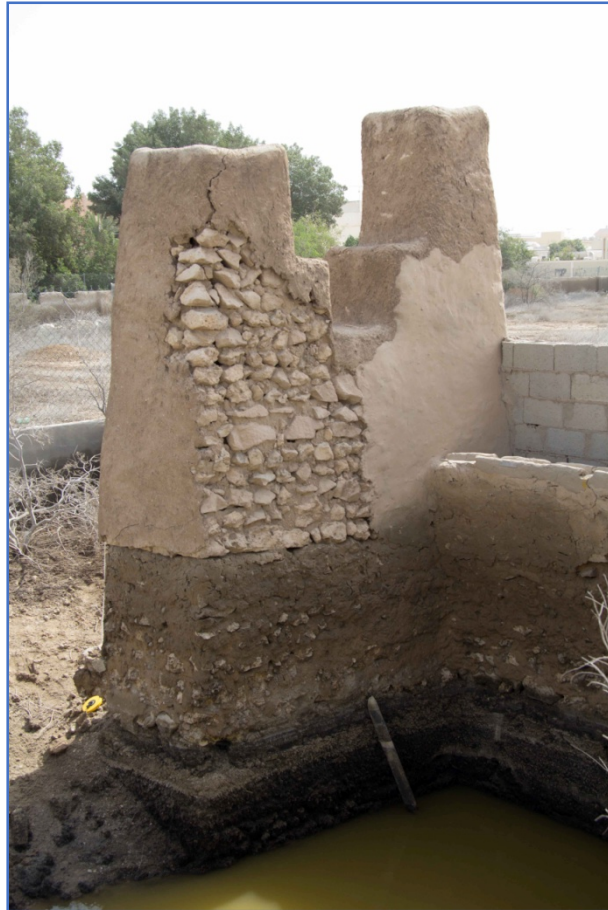
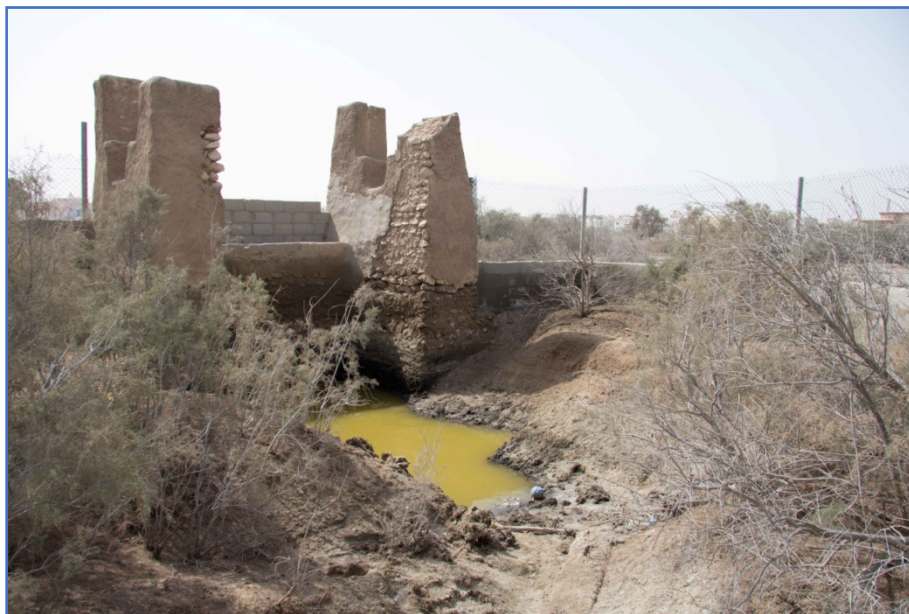
The well has a superstructure built of unfaced sub-angular limestone and consisting of two stepped elongated pillars or uprights (Figures 8 - 13). This stone superstructure would have supported horizontal wooden beams and a wheel, through which a rope ran to lift water from the well (see Figures 100 and 101). The upper part of the superstructure is covered with a very coarse brown render, the lower section with a smoother and light grey brown render. It is not clear if this relates to a repair to the structure, or if there is in fact a structural difference in the renders. For example the coarser upper render may be harder wearing, whereas the lower render may be more waterproof. Future analysis of samples taken from these renders may shed light on this aspect of the well. Other small patches of render appear to relate to repairs to the well.

The masonry superstructure for the lifting mechanism flank the well itself, which although contains some water is now largely backfilled (Figure 14). The well would probably have originally been rectangular in plan and lined with limestone. Water would have been lifted from the well in a leather bag, and poured into the sloping trough that runs between the two stone uprights (Figure 15). From here the water flowed into a rectangular tank on the southern side of the well (Figure 16). This tank had two phases of construction, the earliest core was built of limestone and covered in a thick brown render. A later phase of building raised the wall height of the tank with the addition of another course of limestone, which was covered with a finer hard grey render.

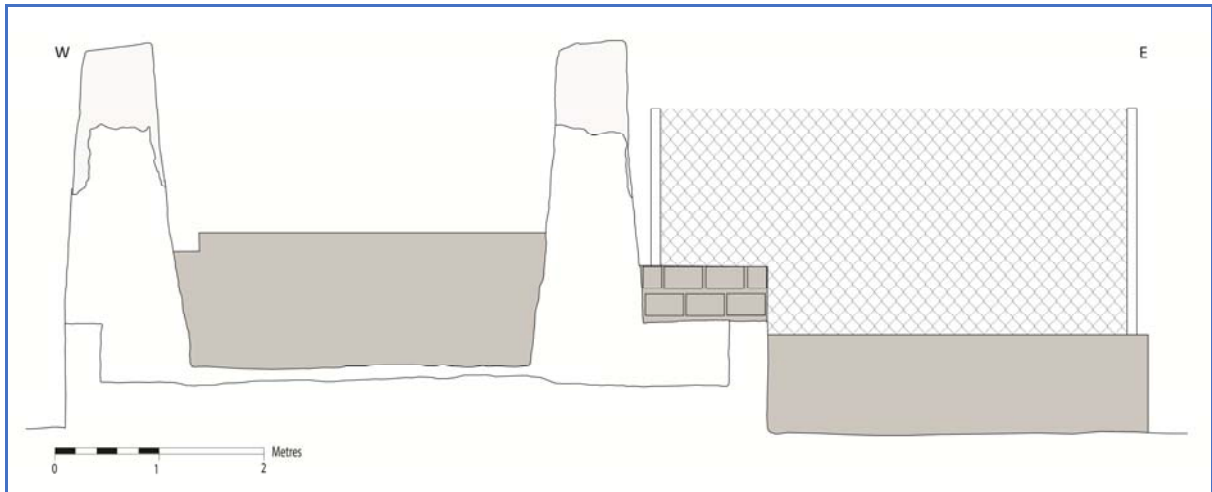
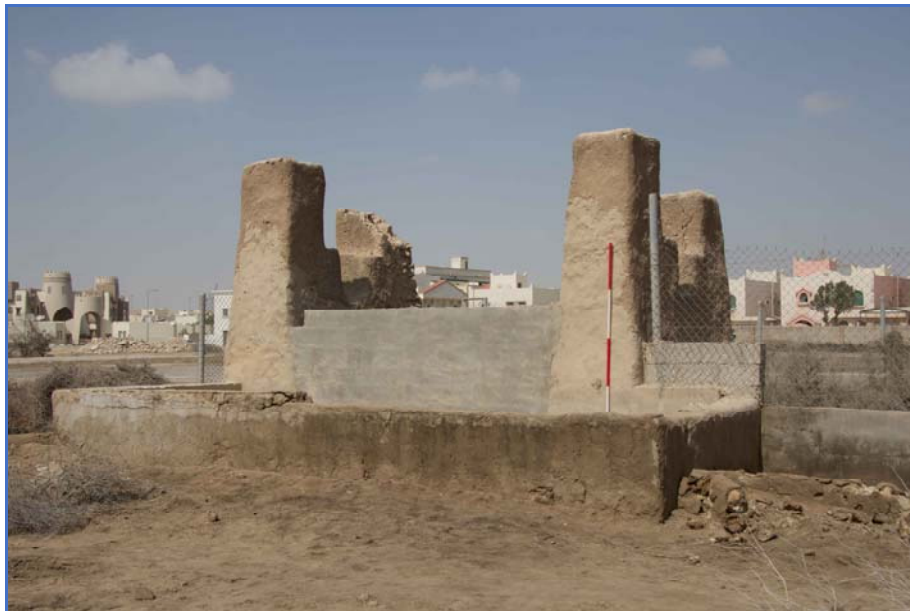
The *Zajara* well has however been enclosed by a modern concrete block wall and chain-link fence, identical to those enclosing Structures 8, 9, 10 and 12. This modern wall also infills the space between the two uprights at the top of the well (Figures 18 and 19). This wall was clearly built after the well had fallen out of use, as the well cannot function with it in place. The modern wall appears to have been built to secure the well, possibly to make the site safer, and reduce the risk of accidentally falling into what originally would have been a fairly deep well.

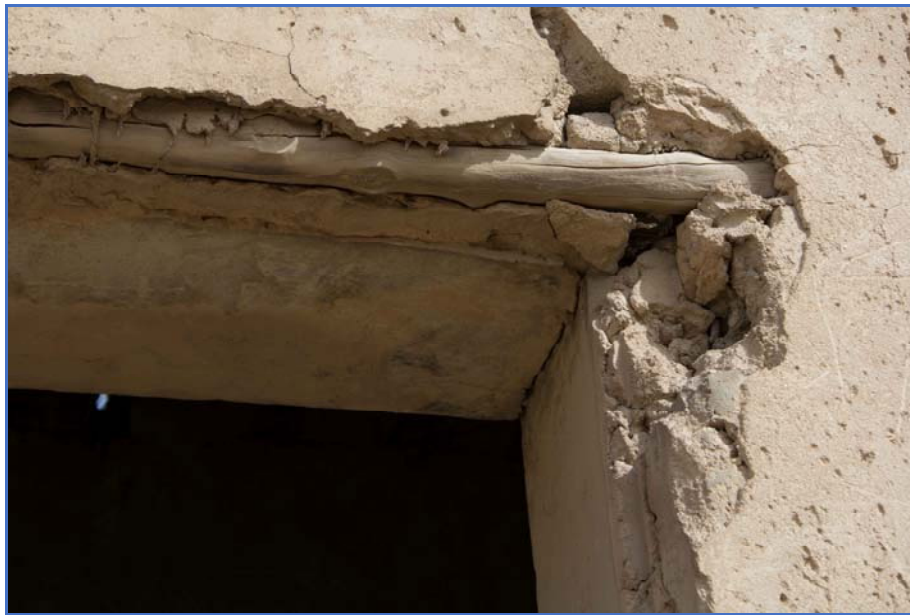
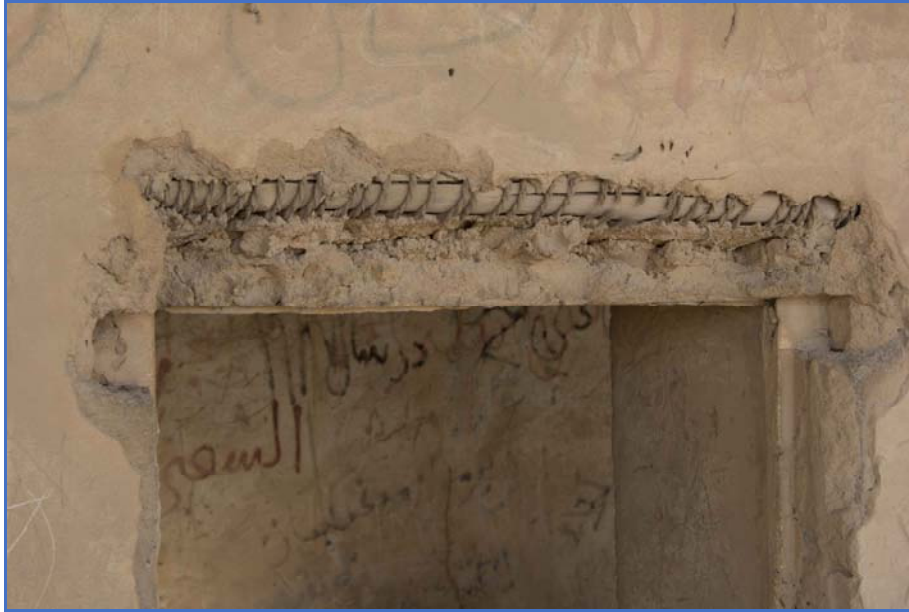
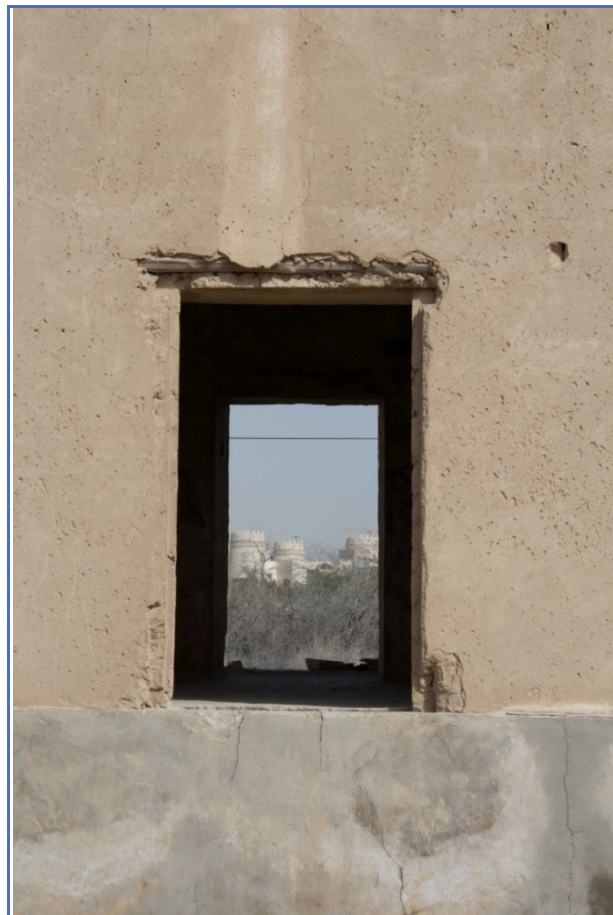
The windows were located low to the ground, in order to create a breeze through the building. The lintels above the windows consist of round *danshal* poles bound with rope (Figures 29 - 31). Most of the window frames were missing, with only the plaster impressions of them left. Originally the windows would have had a wooden frame, and presumably shutters to keep out the rain and dust.

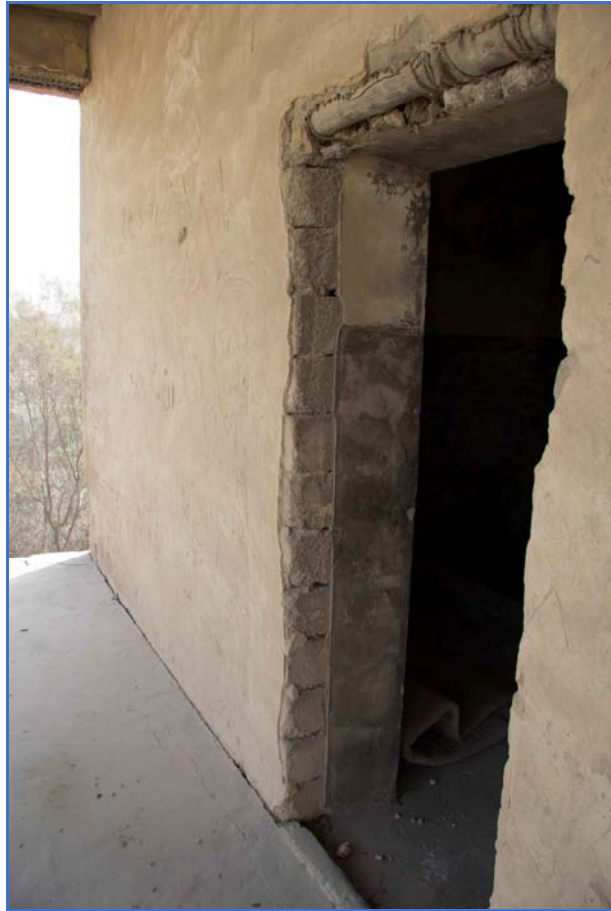
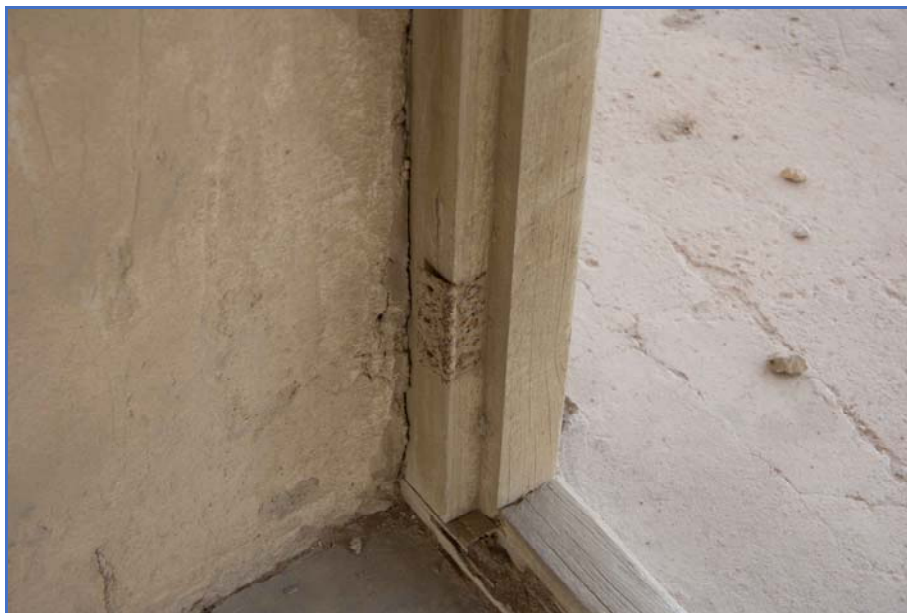
The doorways were constructed in a similar style to the windows, with a lintel consisting of a round beam bound with rope (Figure 32). The doors themselves had been removed, but at least one of the doorways retained its original wooden doorframe and hinges (Figure 33).

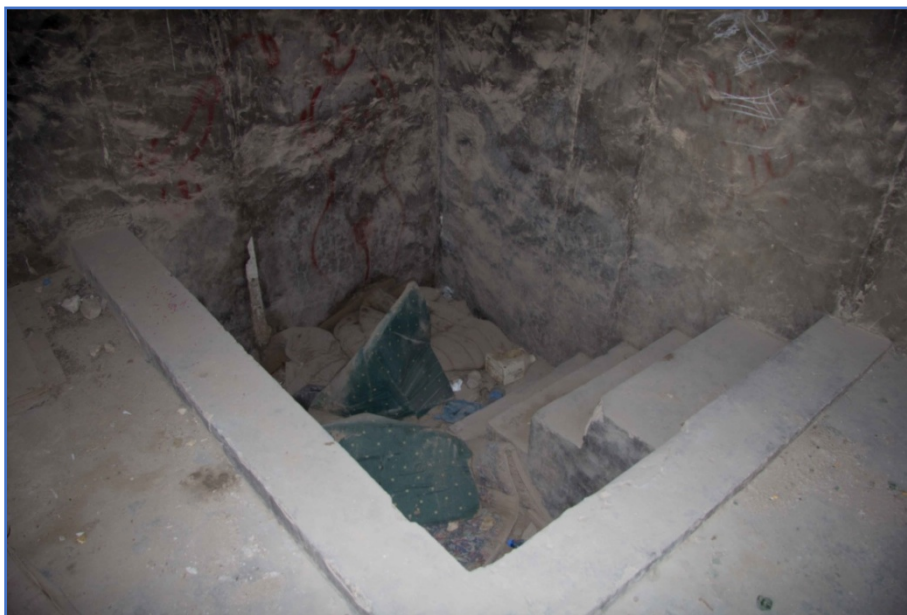
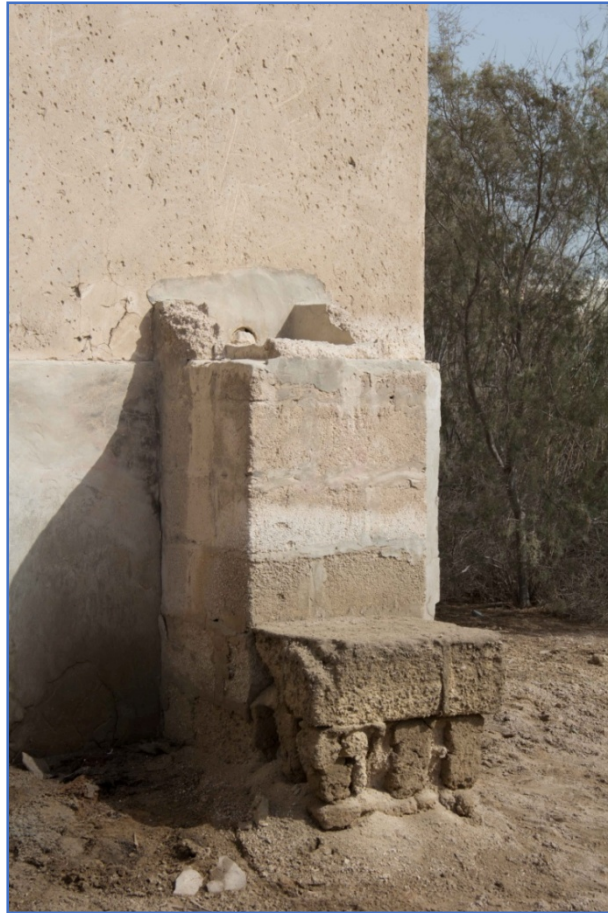
Room 1 would have been used as a seating area, possibly to entertain guests (Figure 37). None of the original furniture remains, but it would presumably have contained rugs on the floor and low seating arranged around the walls. Room 2 contained a sunken bath, surrounded by a small lip and accessed by four concrete steps on its western side (Figure 38). A raised basin on the external face of the south wall of the building was linked by a pipe to the bath, and pumping water into the basin would therefore have filled the bath inside the building (Figure 39). The bath is not common feature of a *majlis*, and its function remains unclear. It has some similarities with a pair of sunken baths previously excavated in the Radwani House in the Msheireb area of the city (Carter and Eddisford 2013). Both baths are probably of a similar mid 20th century date, and so relate to a period when water was becoming more easily available in larger quantities as pumping and piped water was introduced.

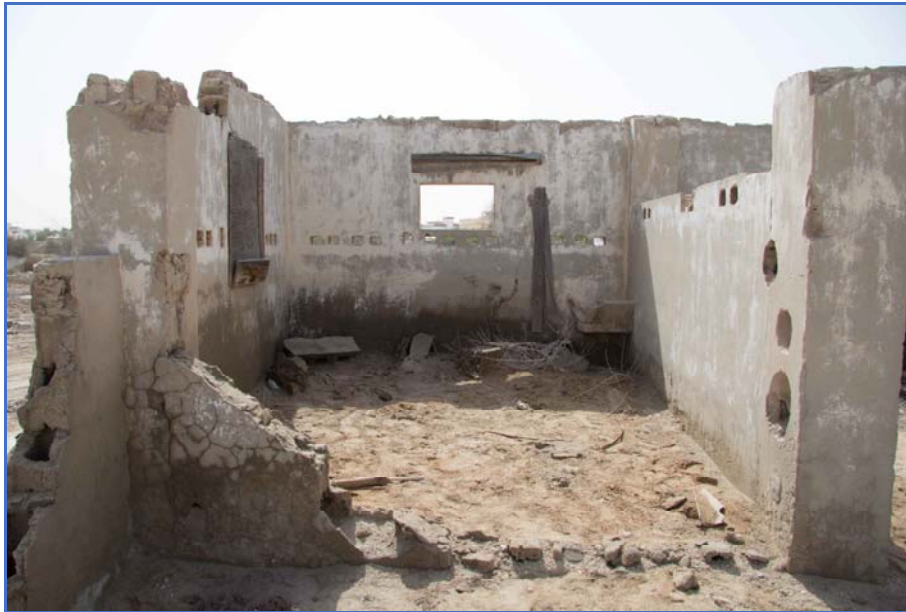
Each of the stalls measured 3.85m deep, most were 2.90m wide, except for the stall at the eastern end which measured 3.20m wide. This eastern stall had the partially demolished remains of a wall enclosing its northern side (Figure 45). All the other stalls had no such wall, however circular holes in the pillars that formed the northern extent of the building indicate that removable horizontal wooden beams would have been used to keep the horses fenced in when necessary. The stalls were divided from each other by low sloping walls, again except for the larger eastern stall that was divided by a more robust taller wall (Figure 45). Each stall had an open rectangular window in its southern wall, although one of these had been bricked in. Holes in the southern wall of the building allowed further ventilation. A metal ring in the centre of the southern wall of each stall could have been used to tether the horses (Figure 46). Each stall also had a small manger in its southwest corner, used to hold food or water for the horses (Figure 47).

Figure 45: The slightly larger eastern stall, looking south.

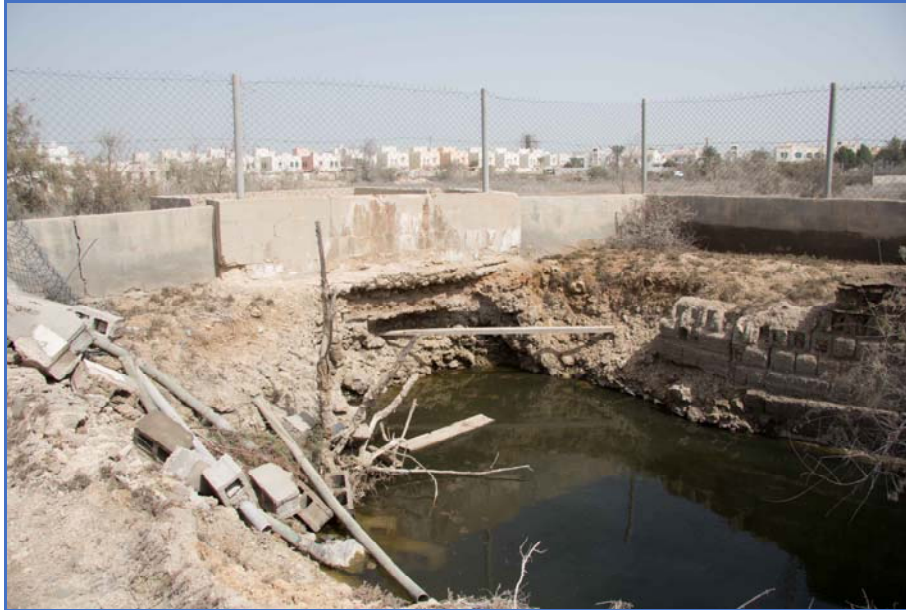
The earliest visible element of the well appears to be parts of a stone lined box well, visible where parts of the later structure have collapsed (Figure 71). Any other elements of this early phase of use have been removed.

Figure 71: Partially infilled well, Structure 8. Note older stone lining to well visible in places.

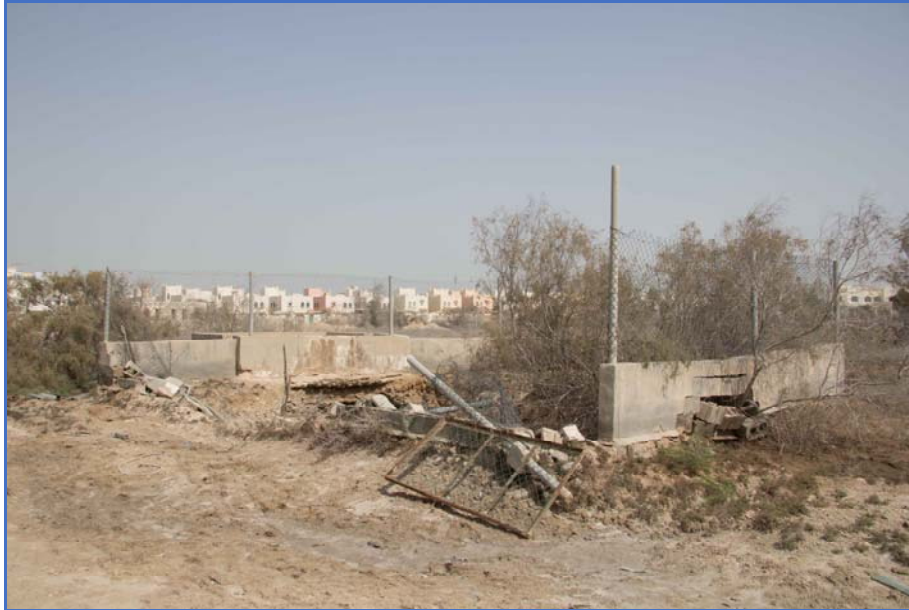
The latest phase of construction consists of a wall and associated chain-link fence that enclose the well (Figure 73). The concrete blocks used in this wall are of higher quality and contain gravel temper as opposed to shell. Although partially collapsed this wall is probably a relatively recent addition, possibly added after the well had fallen out of use.

Figure 73: Partially collapsed modern wall and fence around well, Structure 8.

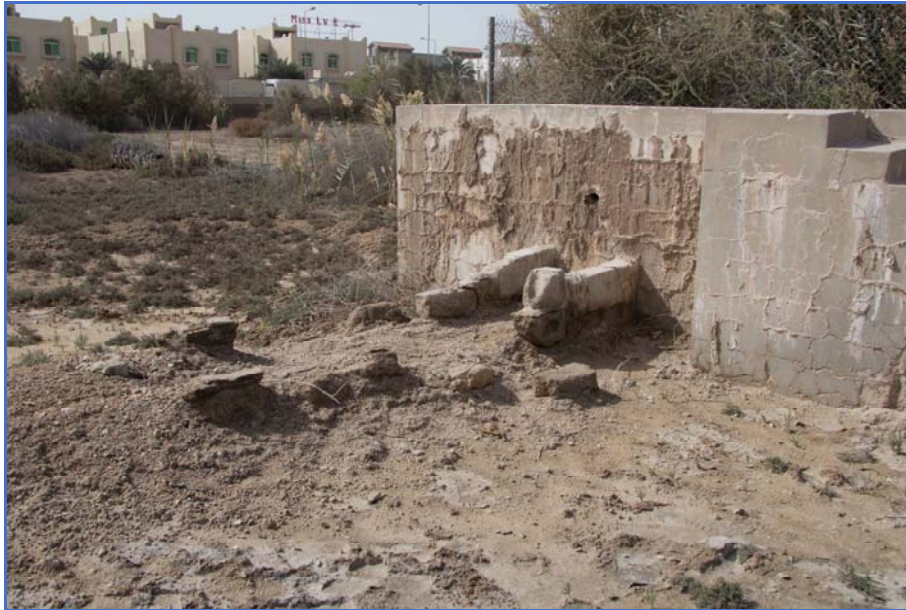
separate brick edged raised water channels on the north, east and west sides (Figure 75). These poorly preserved channels would have fed the water into the surrounding fields to irrigate the area.

Figure 75: Channel leading from the east side of the raised tank of Structure 9.

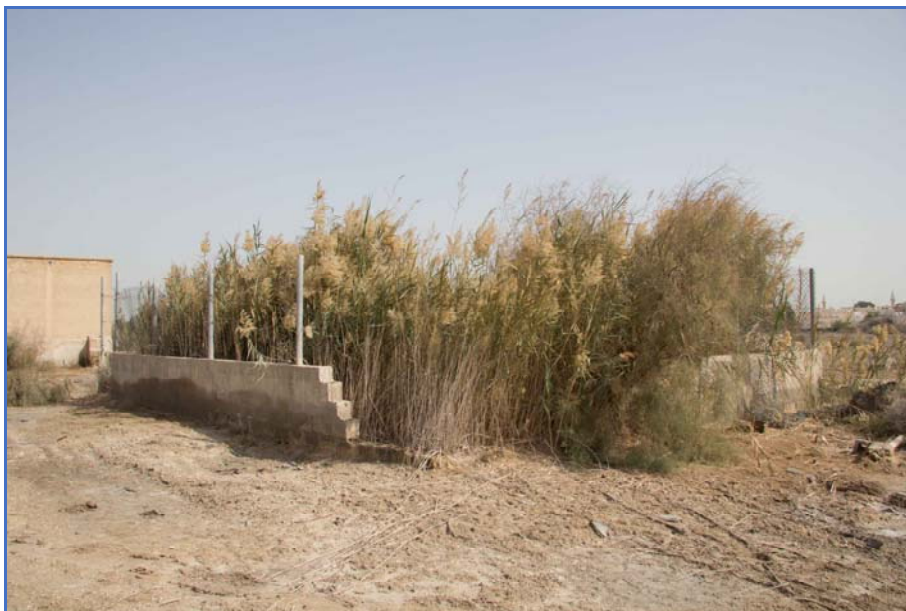
A wall and chain-link fence enclosed the well, harder built of gravel tempered concrete blocks. This fence was a later addition to well, and abutted the earlier raised water tank described above. The enclosure wall had a gate in its northwest corner, and was partially collapsed in the southwest corner (Figure 76)

Figure 76: Partially collapsed wall, enclosing overgrown well, Structure 9, looking north.

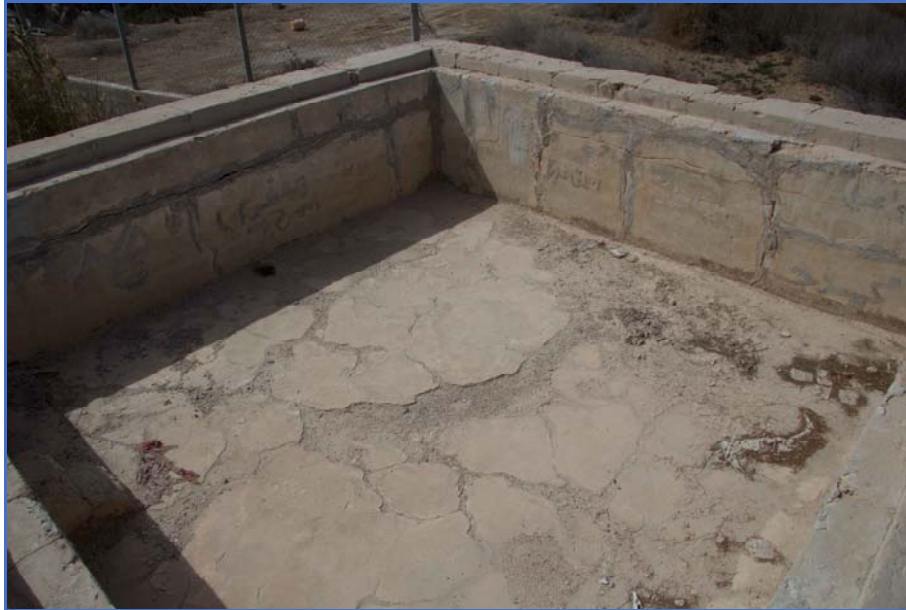
The well was so overgrown with pampas grass was not possible to examine it, however as this plant thrives in wet conditions it seems likely the well continues to contain at least some water. The water tank, located to the north of the well, measured 6.30m north-south and 6.20m east-west (Figure 78). The base of the tank was raised off the ground by 1.70m, the extra height presumably required as it was located in a low lying area of the site. The tank was built of shell tempered concrete blocks, identical to those used to build the other similar tanks on the site. A Drain in the northern side of the tank fed into a very poorly preserved raised channel, running north towards the main agricultural area. The tank was accessed by a set of steps located on the southeastern side of the feature.

Figure 78: Internal view of raised tank associated with Structure 10

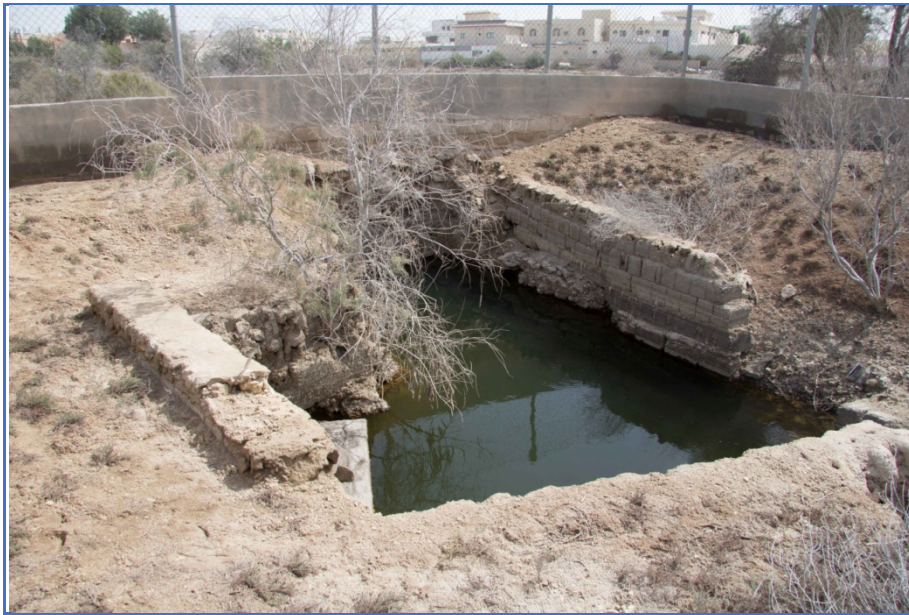
The earlier stone lined well has been altered and expanded to the west (Figure 84). The modifications to the well are constructed of shell tempered concrete blocks, and include a level area on the western side of the well which probably housed a pump. A rectangular tank measured 8.60m north-south and 2.60m east-west and was 0.50m deep (Figure 84). A drain in northern side of the tank would have allowed water to flow into the surrounding irrigation system. A later gravel tempered concrete block wall and chain-link fence enclosed the well and was built directly on top of the earlier tank (Figure 83).

Figure 84: Concrete block lined well, associated with Structure 12, looking southeast.

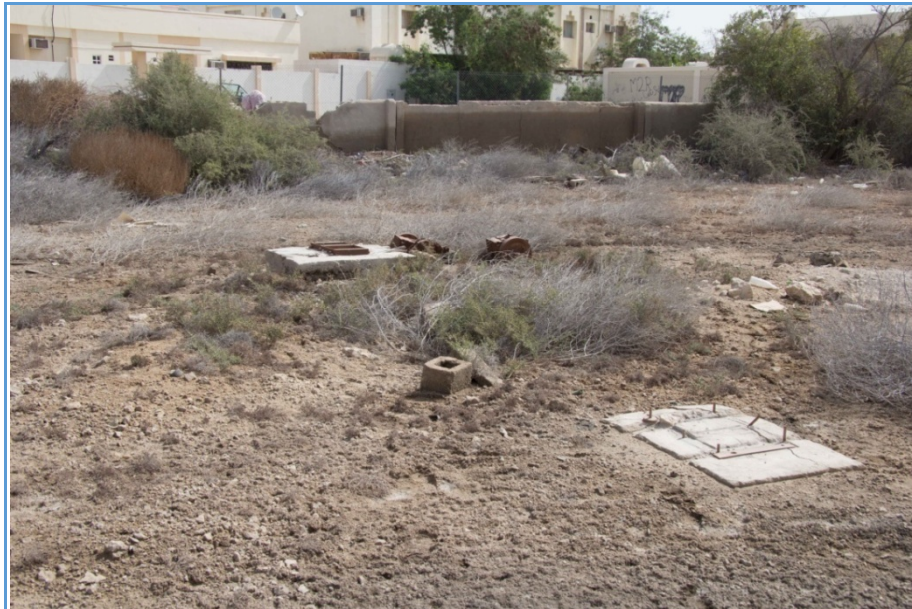
Two rectangular concrete bases were recorded, each with metal fixings to secure machinery. They measured 1.20m by 0.80m and 1.20m by 1.30m respectively and stood a maximum of 0.15m above ground level (Figure 86). Two discarded diesel pumps lay beside one of the bases (Figures 87 and 88), and would certainly have originally been housed on these features, similar to those recorded in-situ adjacent to well and tank Structure 10.

Figure 86: Pump bases Structure 13, with discarded pumps visible behind, looking southeast.

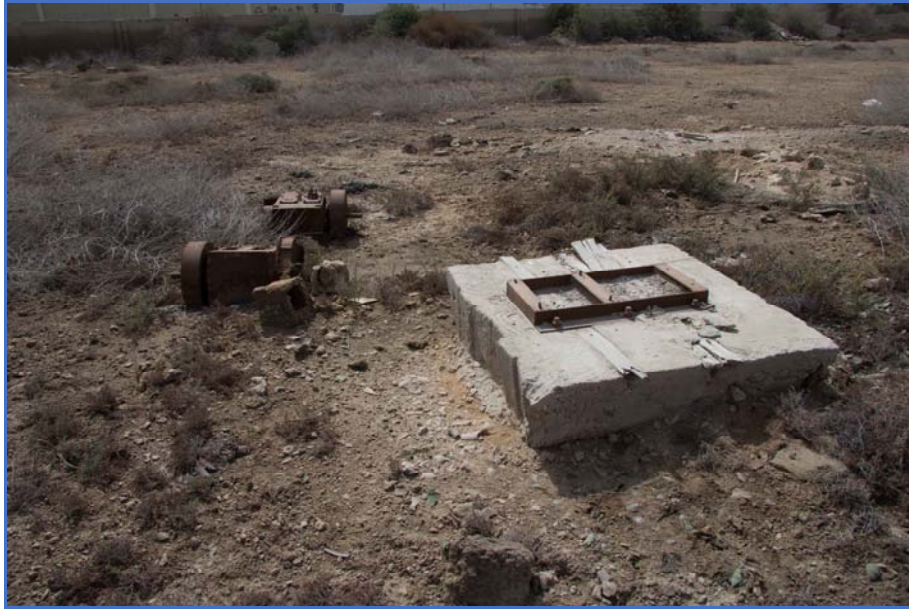
Figure 87: Pump base Structure 13, with discarded pumps to the left, looking south.

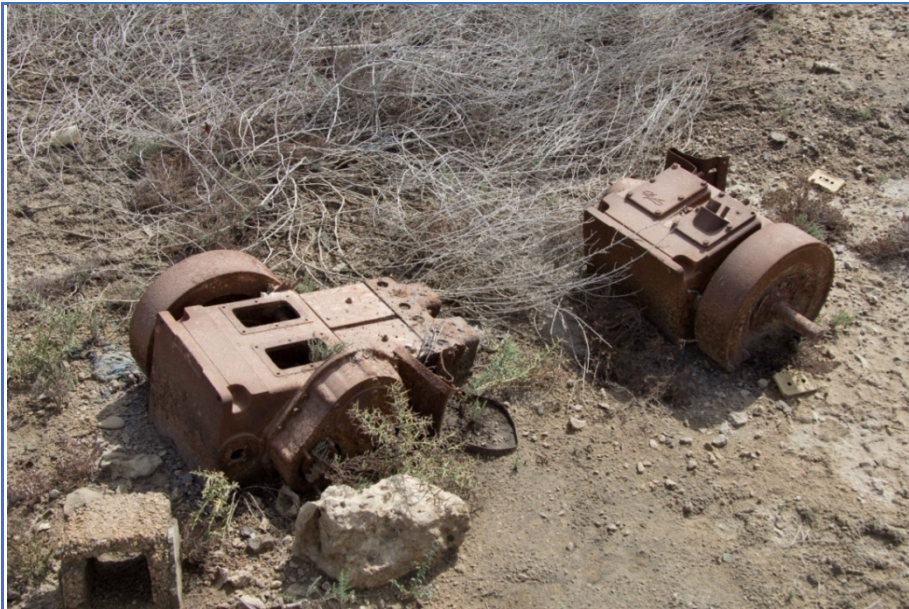
Figure 88: Discarded pumps associated with Structure 13.

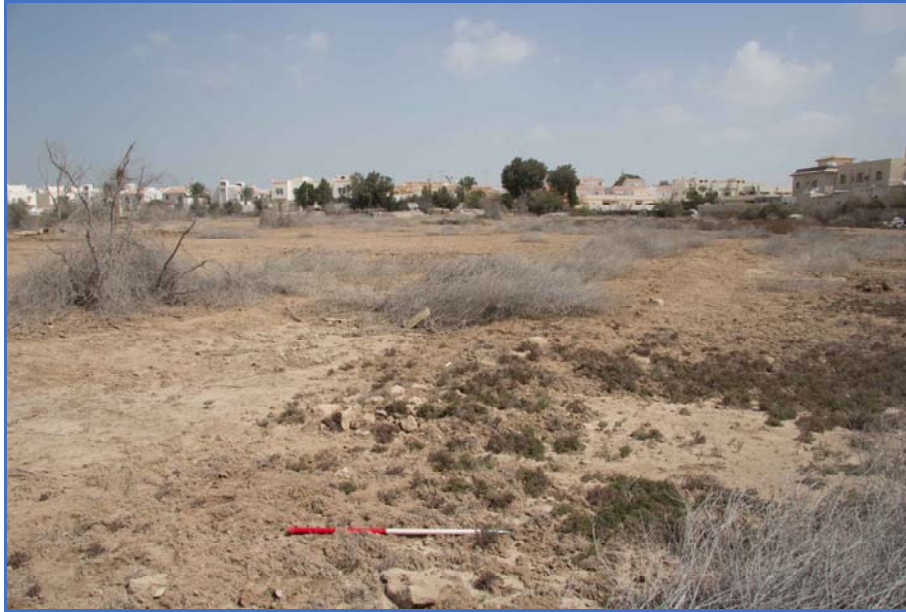
The remains of a field system, visible in the centre of the site, consists of a series of low mounds of soil enclosing small rectangular fields (Figure 89). Water channels would have fed into these plots, allowing them to be irrigated. Glazed ceramic pipes visible within some of the raised field boundaries (Figure 90) are probably a later addition allowing the water flow to be managed more easily.

Figure 89: One of the low banks defining the edge of a field.

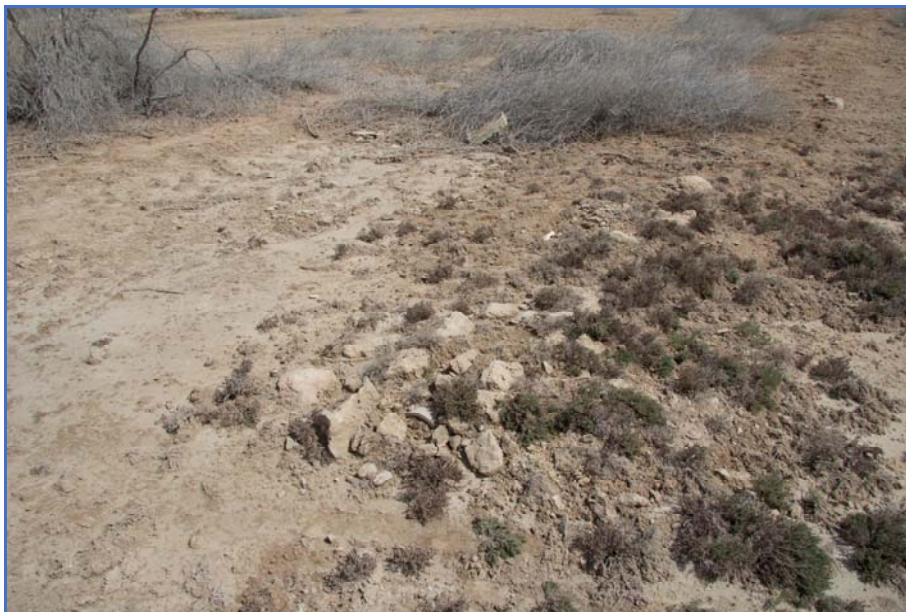
Figure 90: A ceramic pipe, visible within a low banks defining the edge of a field.

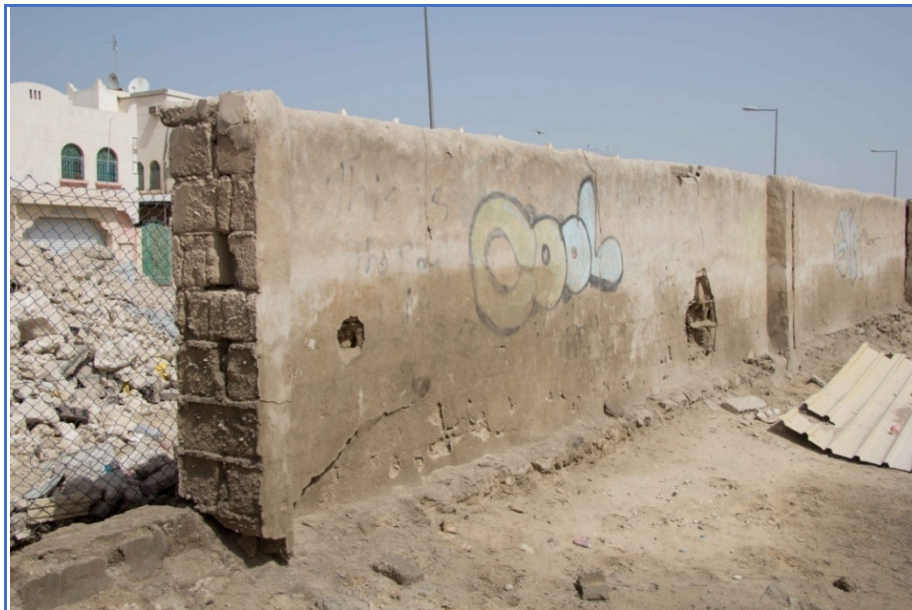
The earliest visible boundary wall for the site was built of shell rich concrete blocks on a single foundation course of unfaced limestone. The wall was 1.80 m high and enclosed much of the site. In several places the addition of later gateways had truncated the wall. The wall was missing from the northwest corner of the site, here it would have originally extended beyond the current boundaries of the site, indicating the site was once larger than its current extent.

The wall was constructed of hollow shell rich concrete blocks measuring 400mm x 200mm x 200m, bonded with a hard grey render, and capped with a concrete lintel. The wall was 200mm wide, consisting of a single row of bricks with 400mm x 400mm brick uprights every c. 7.5m.

The building material and construction suggest the boundary wall is contemporary with many of the irrigation tanks on the site. The wall may be associated with a more intensive use the site following the introduction of diesel pumps. As the land was presumably more valuable due to better irrigation it may have been felt necessary to protect, or stake a more visible claim to the site by enclosing it with a relatively substantial wall. This presumably would have occurred within a process of changes in land ownership, in which access to resources shifted from communal or tribal control to control by an increasingly powerful if nascent state apparatus dominated by a few elite groups.

Figure 91: External wall, Structure 15.

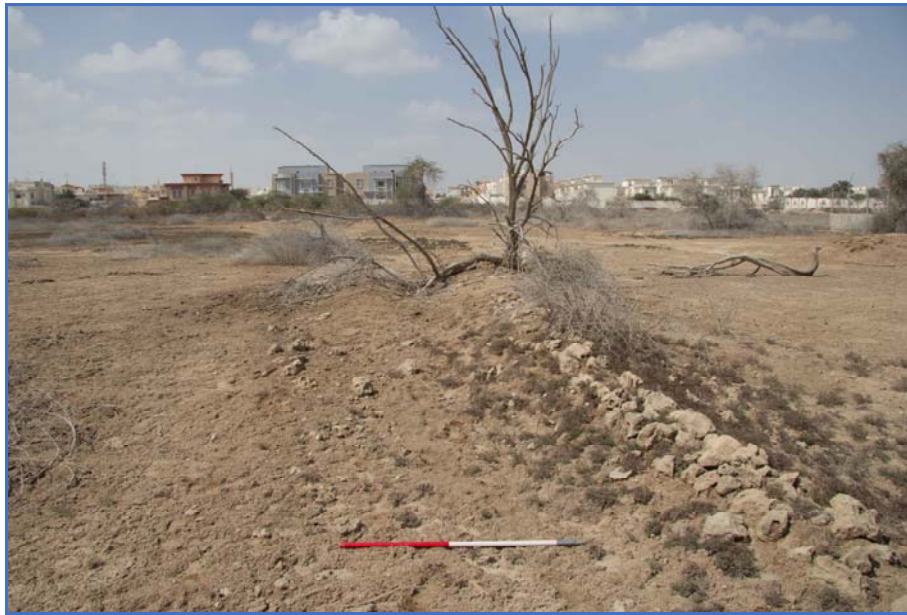
Structure 16 consisted of a water channel or canal built of unfaced limestone and running across the centre of the site on an east-west orientation. This feature survived as a low mound, in sides of which the edges of the stone lined channel were visible. This feature is located at the southern extent of the area of agriculture visible on the 1947 aerial photograph of the site (Figure 4). It is therefore possible that this raised canal would have fed into the agricultural area to the north, prior to the site being enlarged in the second half of the 20th century.

Figure 92: Stone edged irrigation channel Structure 16, looking west.

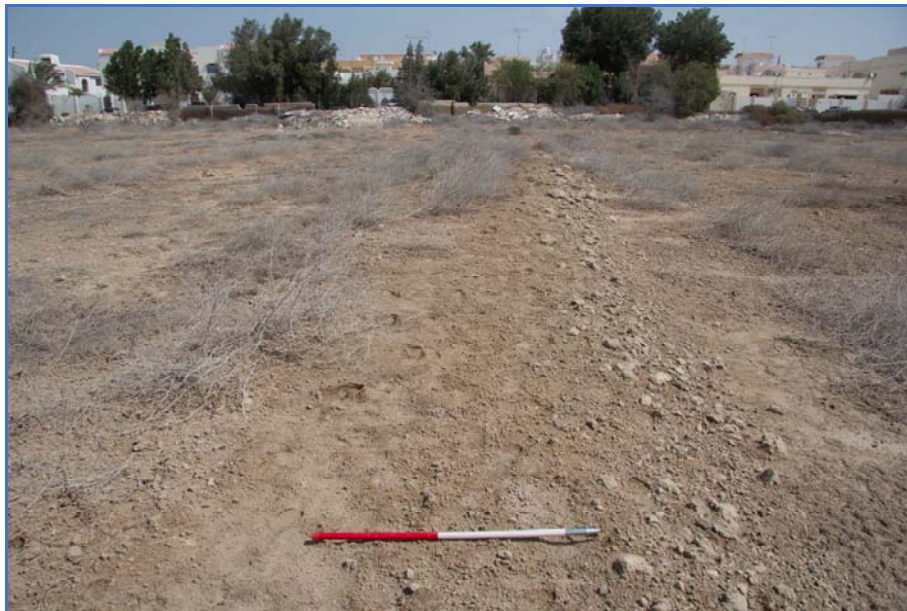
Figure 93: Stone edged irrigation channel Structure 16, looking east.

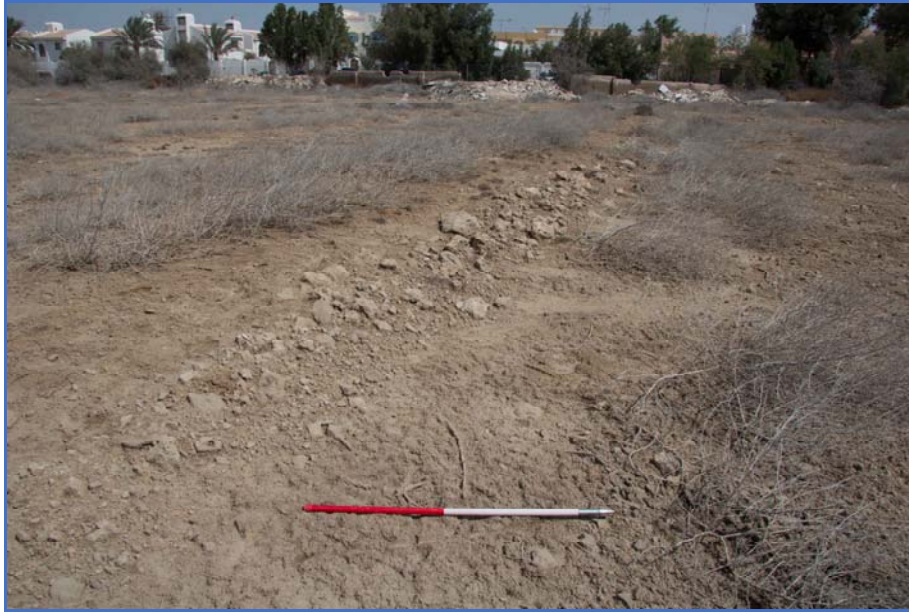
Figure 94: Stone edged irrigation channel Structure 16, looking east.
